# FACILITY CONDITION ASSESSMENT

## **Griffin Structures - City of Laguna Beach FCA\_Inventory\_PMP**

City Hall Complex  
505 Forest Avenue  
Laguna Beach, CA 92651

*October 14, 2024*

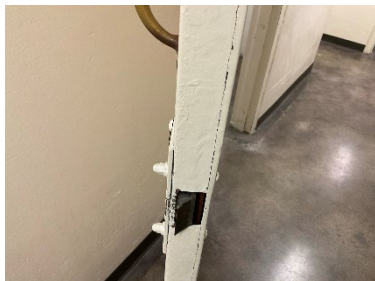
**Interior Door in Poor condition.**

Steel, Standard  
City Hall  
Police Station

The doors are splitting and deteriorating from rust and age. - AssetCALC ID: 7718178

Uniformat Code: C1030  
Recommendation: **Replace in 2024**

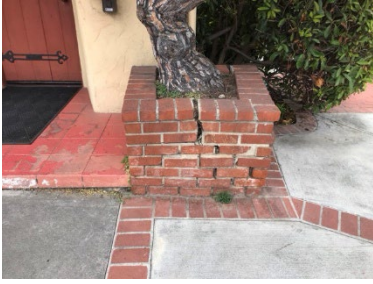
### Seating Wall in Poor condition.

Brick/Stone, 18" Height  
Site  
Fire Station Site

Exterior planter walls are damaged/deteriorating. - AssetCALC ID: 7680227

Uniformat Code: G2060  
Recommendation: **Replace in 2026**
