FACILITY CONDITION ASSESSMENT

Griffin Structures - City of Laguna Beach FCA _Inventory_PMP

October 14, 2024

Corporation Yard
1900 Laguna Canyon Road
Laguna Beach, CA 92651

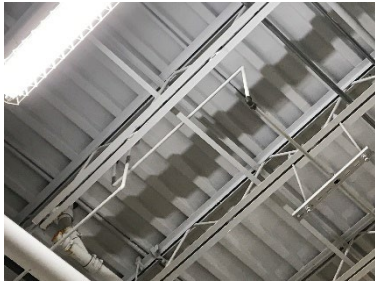
Piping & Valves in Poor condition.

Piping Copper, Domestic Water, 0.5 IN
Corporation Yard
Throughout Building

Supply piping throughout is reportedly leaking from pin-hole leaks. Location picture of water supply for 2nd floor DF. - AssetCALC ID: 7649574

Uniformat Code: D2010
Recommendation: **Replace in 2024**

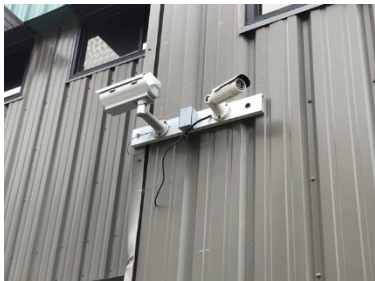
Security/Surveillance System in Failed condition.

Full System Upgrade, Average Density
Corporation Yard
Building Exterior

System was not working at time of assessment. - AssetCALC ID: 7649539

Uniformat Code: D7030
Recommendation: **Replace in 2024**

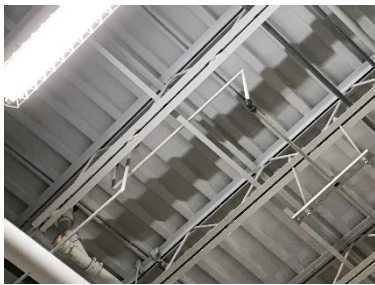
The copper supply piping is in poor condition. The piping has developed pin-hole leaks throughout. A professional consultant must be retained to analyze the existing condition, provide recommendations and, if necessary, estimate the scope and cost of any required repairs. The cost of this study is included in the cost tables. A budgetary cost allowance to replace the copper supply piping is also included.

Recommended Follow-up Study: in Poor condition.

Plumbing, Domestic Water Supply Piping
Corporation Yard
Throughout Building

The copper supply piping throughout has reportedly developed pin-hole leaks. - AssetCALC ID: 7659205

Uniformat Code: P2030
Recommendation: **Evaluate/Report in 2024**

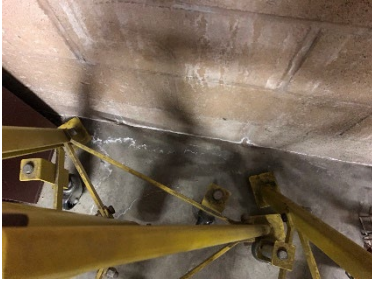
There is water infiltration in the maintenance shop, near the fire riser, of unknown origin. A professional consultant must be retained to analyze the existing condition, provide recommendations and, if necessary, estimate the scope and cost of any required repairs. The cost of this study is included in the cost tables. Due to the ambiguity of the required repair scope at the time of this assessment, the cost for any possible subsequent repairs is not included.

Recommended Follow-up Study: in Poor condition.

When it rains water comes into building apparently from below grade under slab, or through inside CMU walls to grade, then seeping out of lowest blocks where the efflorescence is observed. - AssetCALC ID: 7649577

Uniformat Code: P2030
Recommendation: **Evaluate/Report in 2024**

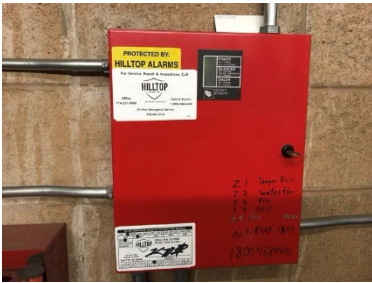
Fire Alarm Panel in Poor condition.

Uniformat Code: D7050
Recommendation: **Replace in 2024**
