FACILITY CONDITION ASSESSMENT

Griffin Structures - City of Laguna Beach FCA _Inventory_PMP

Fire Station #1
505 Forest Avenue
Laguna Beach, CA 92651

October 15, 2024

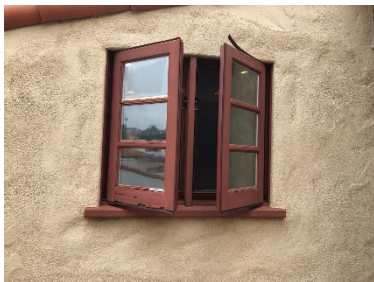
Exterior Walls in Poor condition.

any painted surface
Fire Station #1
Building Exterior

The wood frame windows require repair work and painting to maintain and extend their life. - AssetCALC ID: 7682262

Uniformat Code: B2010
Recommendation: **Prep & Paint in 2024**

Cost Estimate: \$6,500

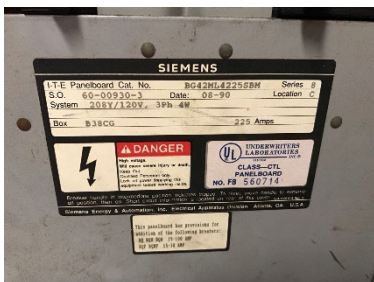
The electrical distribution system is assumed to be original construction and beyond its expected useful life.

Electrical System in Poor condition.

Full System Renovation/Upgrade, Medium Density/Complexity
Fire Station #1
Throughout

The electrical system is reportedly failing gradually with multiple repair/replacements that have been necessary. - AssetCALC ID: 7680210

Uniformat Code: D5020
Recommendation: **Replace in 2024**

Cost Estimate: \$490,400

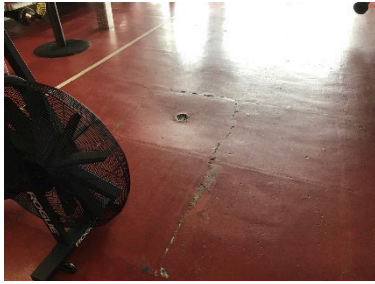
Flooring in Poor condition.

any surface, w/ Epoxy Coating
Fire Station #1
Apparatus Bay

The apparatus bay floor finish is peeling and worn. - AssetCALC ID: 7680182

Uniformat Code: C2030
Recommendation: **Prep & Paint in 2024**

Cost Estimate: \$126,300
