FACILITY CONDITION ASSESSMENT

Fire Station #2
285 Agate Street
Laguna Beach, CA 92651

164043.24R000-006.354

October 14, 2024

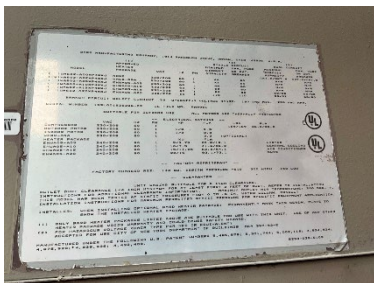
Split System in Poor condition.

Condensing Unit/Heat Pump, 5 TON
Fire Station #2
Building exterior

This condensing unit is at the end of its useful service life, plus has moderate levels of corrosion on its fins and cover. - AssetCALC ID: 7816032

Uniformat Code: D3030
Recommendation: **Replace in 2024**

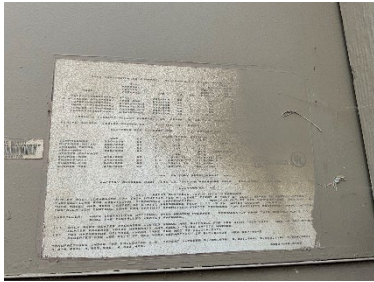
Heat Pump in Poor condition.

This Bard unit is operational, uses R-22 refrigerant and is beyond its expected useful life. - AssetCALC ID: 7816075

Uniformat Code: D3030
Recommendation: **Replace in 2024**

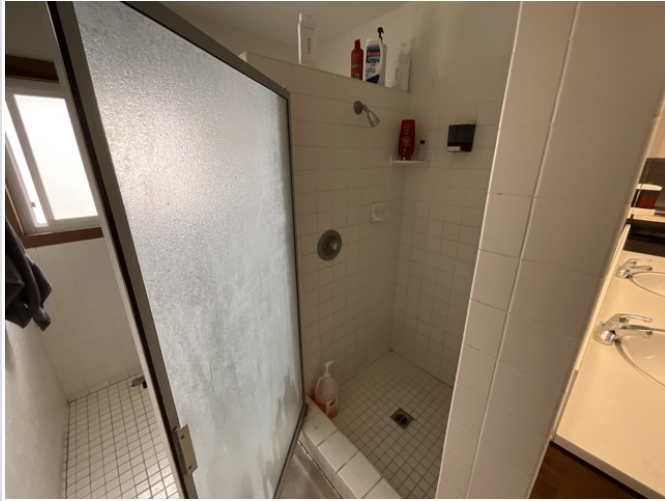
SHOWER NOT ACCESSIBLE

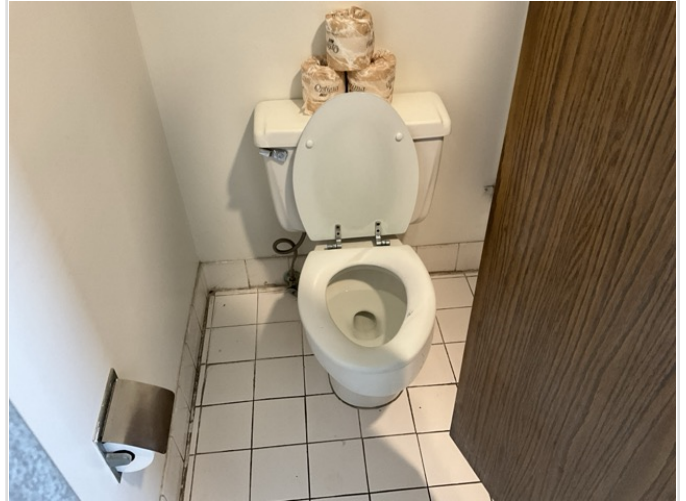
TOILET STALL NOT ACCESSIBLE

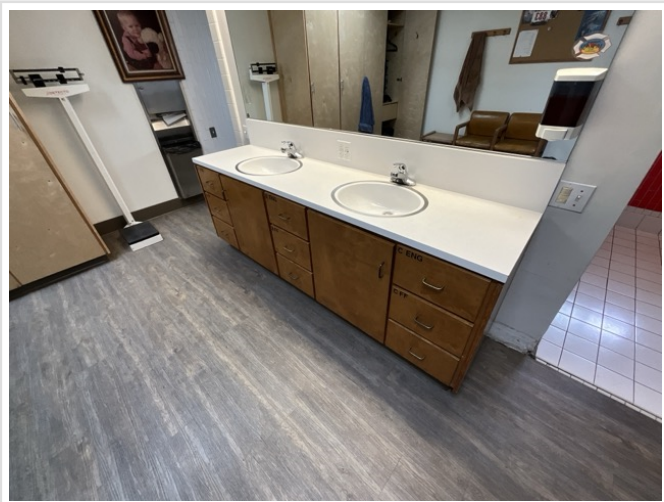
LAVATORY CLEARANCE

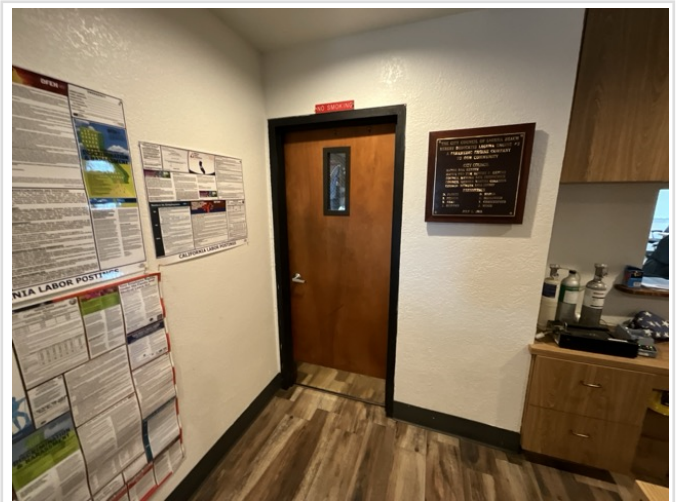
DOOR HARDWARE

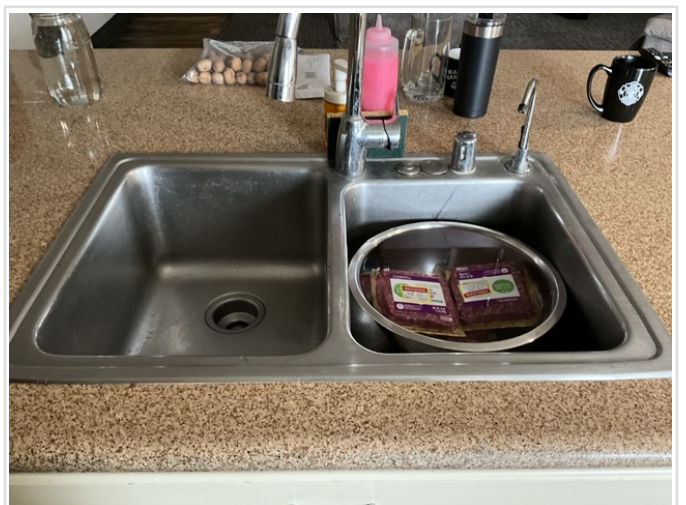
KITCHEN SINK HARDWARE
