# FACILITY CONDITION ASSESSMENT

## **Griffin Structures - City of Laguna Beach FCA \_Inventory\_PMP**

Fire Station #3  
2900 Alta Laguna Boulevard  
Laguna Beach, CA 92651

*October 14, 2024*

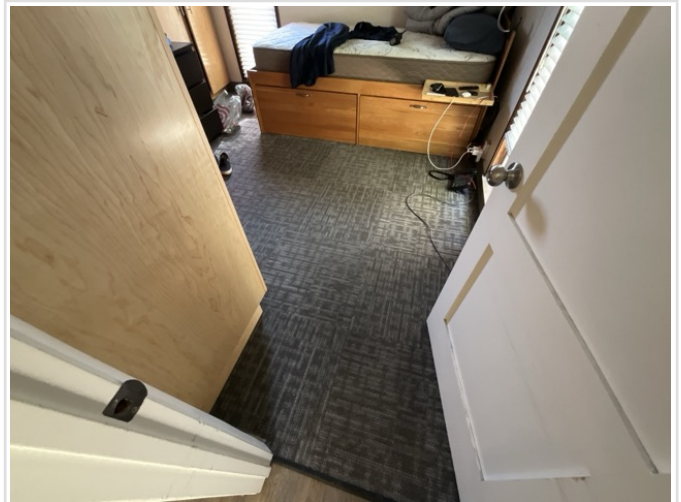
NON-COMPLIANT DOOR HARDWARE

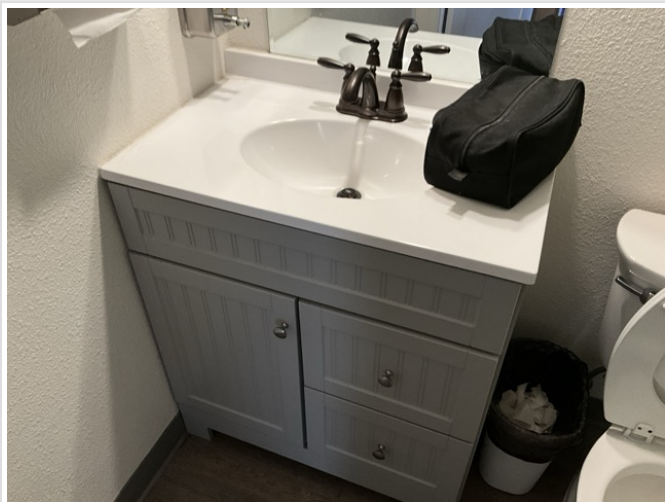
LAVATORY WITH NO CLEARANCE

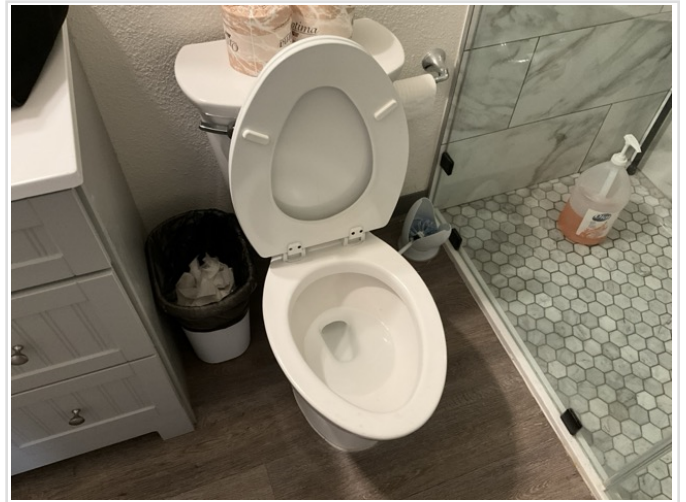
NON-COMPLIANT TOILET
