FACILITY CONDITION ASSESSMENT

Griffin Structures - City of Laguna Beach FCA

Laguna Beach Community & Susi Q Center
380 Third Street
Laguna Beach, CA 92651

August 26, 2024

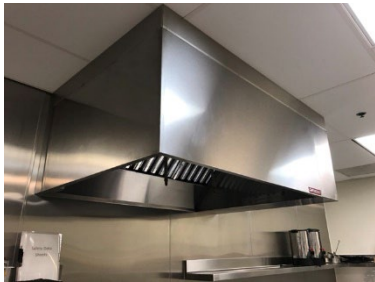
The foodservice equipment is in fair condition, with the kitchen exhaust hood in poor condition.

Foodservice Equipment in Poor condition.

The exhaust hood is assumed to be original construction and has exceeded its expected useful life. -
AssetCALC ID: 7702493

Uniformat Code: E1030
Recommendation: **Replace in 2024**

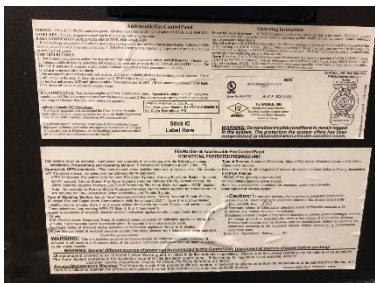
The fire alarm panel is beyond its expected useful life and in poor condition. The fire alarm and security systems are in fair condition.

Fire Alarm Panel in Poor condition.

The fire alarm panel has reached the end of its expected useful life and should be replaced soon. -
AssetCALC ID: 7690441

Uniformat Code: D7050
Recommendation: **Replace in 2024**
