FACILITY CONDITION ASSESSMENT

Griffin Structures - City of Laguna Beach FCA

Lifeguard Headquarters
175 N. Coast Highway
Laguna Beach, CA 92651

August 14, 2024

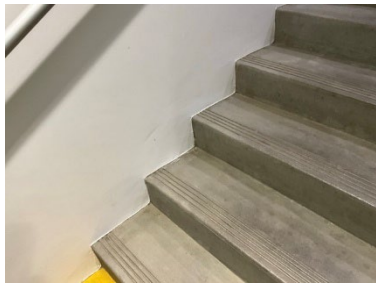
Civil, General Design
Lifeguard Headquarters
Throughout building

The foundation wall is in poor condition. Water is seeping in through the wall. Most noticeably, at the eastern interior staircase. The basement is presumably below sea level, and given the building's proximity to the ocean, it is suspected to be sea water, not plumbing or sewer water. - AssetCALC ID: 7637011

Uniformat Code: P2030
Recommendation: **Replace in 2024**
