FACILITY CONDITION ASSESSMENT

Griffin Structures - City of Laguna Beach FCA

Lost Pier Cafe
31131 CA-1, PCH
Laguna Beach, CA 92651

August 13, 2024

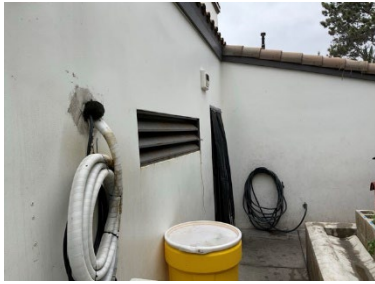
Exterior Walls in Poor condition.

any painted surface, 1-2 Story Building
Lost Pier Cafe
Building Exterior

The painted finish is cracking and spalling at multiple locations. - AssetCALC ID: 7701877

Uniformat Code: B2010
Recommendation: **Prep & Paint in 2024**

Cost Estimate: \$37,200

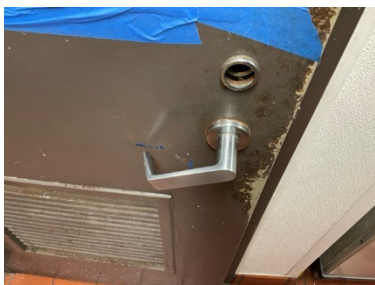
Door Hardware in Poor condition.

Office, per Door
Lost Pier Cafe
Throughout building

The door hardware is in deteriorated condition. - AssetCALC ID: 7701904

Uniformat Code: C1030
Recommendation: **Replace in 2024**

Cost Estimate: \$4,300

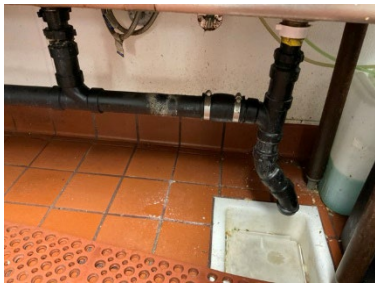
Plumbing System in Poor condition.

Supply & Sanitary, Medium Density (excludes fixtures)
Lost Pier Cafe
Throughout building

The plumbing system is not draining properly, with ongoing issues including strong sewer gas odors. - AssetCALC ID: 7701875

Uniformat Code: D2010
Recommendation: **Replace in 2024**

Cost Estimate: \$115,800

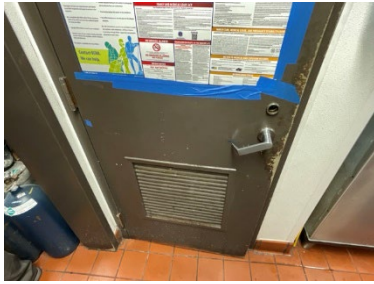
Interior Door in Poor condition.

Wood, Solid-Core
 Lost Pier Cafe
 Throughout building

The doors are in failing condition with deteriorating finishes and frames. - AssetCALC ID: 7701879

Uniformat Code: C1030
 Recommendation: **Replace in 2024**

Cost Estimate: \$8,700

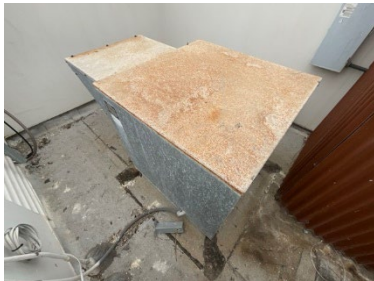
Foodservice Equipment in Poor condition.

Exhaust Hood, 8 to 10 LF
 Lost Pier Cafe
 Kitchen

The exhaust hood is assumed to be original construction, and has exceeded its expected useful life. - AssetCALC ID: 7701884

Uniformat Code: E1030
 Recommendation: **Replace in 2024**

Cost Estimate: \$27,900

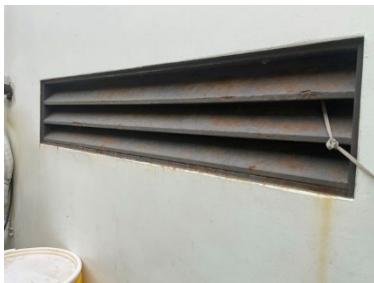
Louvers in Poor condition.

Aluminum
 Lost Pier Cafe
 Building Exterior

The louvers are corroded and deteriorating. - AssetCALC ID: 7701914

Uniformat Code: B2070
 Recommendation: **Replace in 2024**

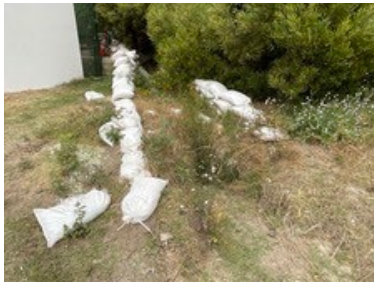
Recommended Follow-up Study: in Poor condition.

Civil, Site Drainage
Site
Site

Management reported that the storm water drainage is an ongoing issue. The piping constantly gets clogged and the poor grading causing it to flood the area reaching into the restaurant - AssetCALC ID: 7701888

Location	UF Code	Description	Condition	Plan Type	Cost
Lost Pier Cafe / Site	P2032	Engineering Study, Civil, Site Drainage, Evaluate/Report	Poor	Performance/Integrity	\$43,300
TOTAL (1 items)					\$43,300

Uniformat Code: P2030
Recommendation: **Evaluate/Report in 2024**
