# FACILITY CONDITION ASSESSMENT

## **Griffin Structures - City of Laguna Beach FCA**

Orange County Public Library - Laguna Beach

*July 23, 2024*

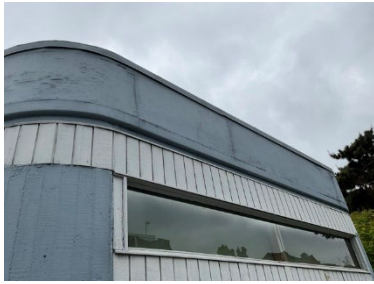
### Exterior Walls in Poor condition.

Wood Siding  
 Library Building  
 Building Exterior Upper Wall

The wood siding is showing signs of moisture rot and failing finishes. - AssetCALC ID: 7640954

Uniformat Code: B2010  
 Recommendation: **Replace in 2024**

Cost Estimate: \$24,100

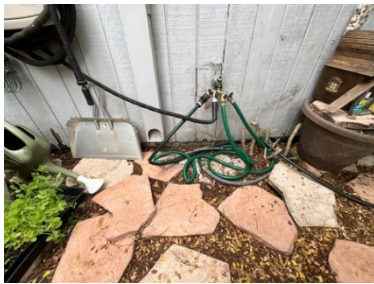
### Exterior Walls in Poor condition.

Wood Siding  
 Library Building  
 Building Exterior Lower Wall

The wood siding is showing signs of moisture rot at the ground level of the walls. - AssetCALC ID: 7640969

Uniformat Code: B2010  
 Recommendation: **Replace in 2024**

Cost Estimate: \$477,900

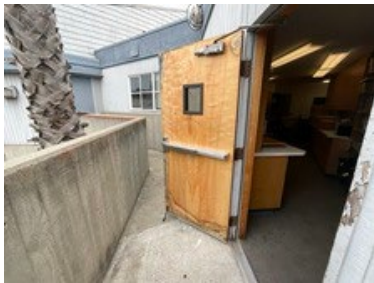
### Exterior Door in Failed condition.

Wood, Solid-Core  
 Library Building  
 Rear Entrance to Office Space

The door and door frame are significantly deteriorated and should be replaced soon. - AssetCALC ID: 7640966

Uniformat Code: B2050  
 Recommendation: **Replace in 2024**

Cost Estimate: \$3,300

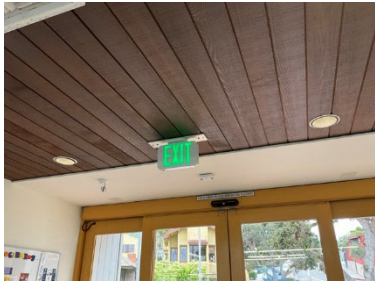
**Fire Alarm System in Poor condition.**

The installation date of this system is assumed and has likely exceeded its expected useful life. - AssetCALC ID: 7640988

Uniformat Code: D7050  
Recommendation: **Upgrade/Install in 2024**

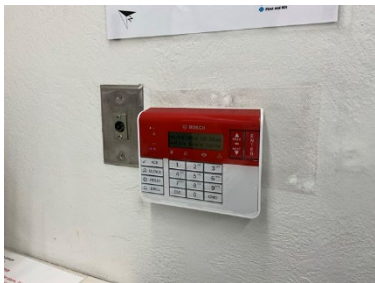
**Fire Alarm Panel in Poor condition.**

The installation date of this panel is assumed, and the panel has likely exceeded its expected useful life. - AssetCALC ID: 7640960

Uniformat Code: D7050  
Recommendation: **Replace in 2024**

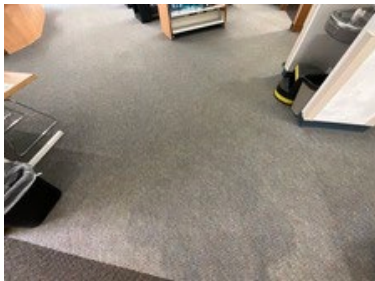
**Flooring in Poor condition.**

The carpet flooring is deteriorated with observed signs of age and wear. - AssetCALC ID: 7640955

Uniformat Code: C2030  
Recommendation: **Replace in 2024**

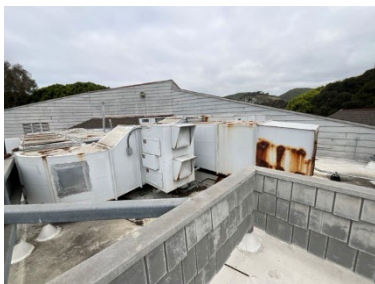
**Air Handler in Poor condition.**

Little information is available for this unit. Capacity is assumed. Although functional, the unit is showing signs of wear with significant levels of corrosion on the unit and ductwork. - AssetCALC ID: 7640972

Uniformat Code: D3050  
Recommendation: **Replace in 2024**

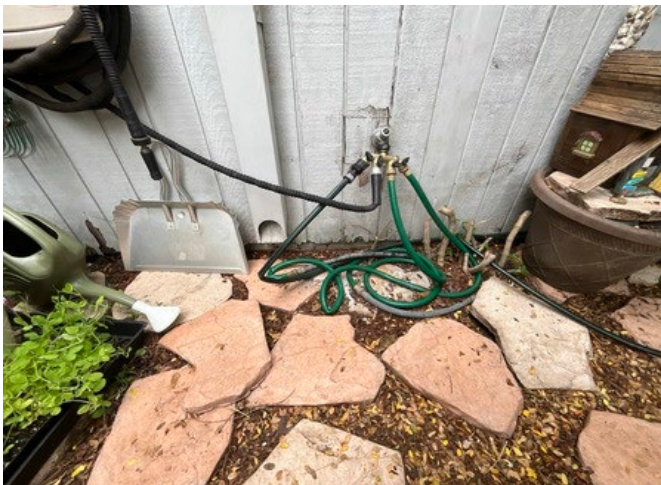
5 – EXTERIOR WALLS

The exterior walls consist of wood siding which is in poor condition. Near the roof the wood siding is showing signs of moisture rot and failing finishes. At the base of the walls the wood siding is also showing signs of moisture rot. The exterior doors and windows are in fair condition, except for the door and door frame at the rear entrance which is significantly deteriorated.

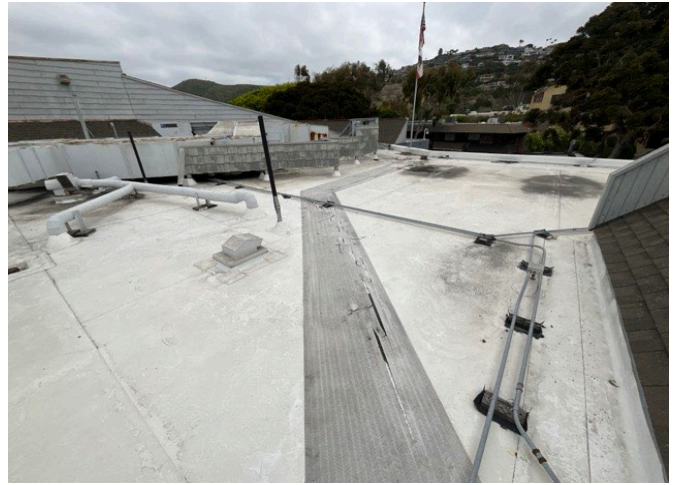
8 – ROOF

The asphalt shingle and single ply roof coverings are in fair condition, with some cracks observed in the single ply roof that need to re-sealed or repaired.

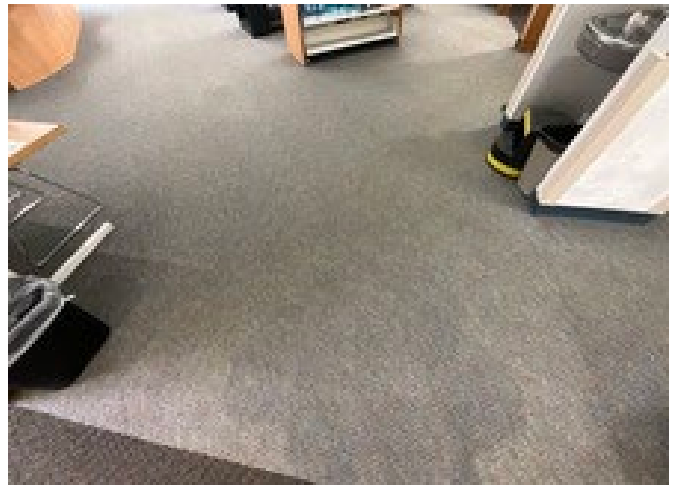
10 – FLOOR FINISH

The interior construction and interior finishes assets are generally in fair condition, except for the carpet which is deteriorated with signs of age and wear.

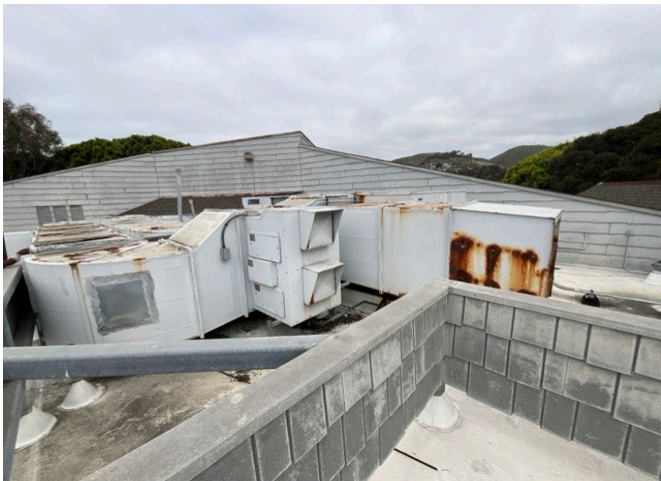
11 – AIR HANDLER

A rooftop air handling unit provides heating and cooling for the facility, but it is in poor condition with significant corrosion on the unit and associated components.
