**BUREAU
VERITAS**

FACILITY CONDITION ASSESSMENT

Griffin Structures - City of Laguna Beach FCA

Public Works
479 Ocean Avenue
Laguna Beach, CA 92651

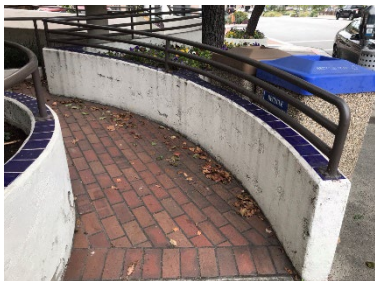
Stucco
Public Works
Building Exterior

Exterior Walls in Poor condition.

Stucco finishes at exterior ramp and planters are damaged. - AssetCALC ID: 7668672

Uniformat Code: B2010
Recommendation: **Repair in 2024**

Cost Estimate: \$12,500

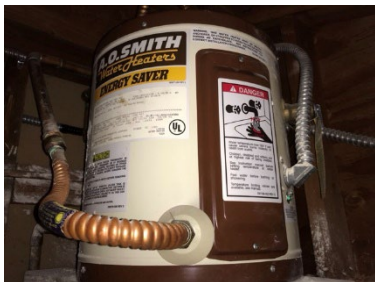
Electric, Residential, 6 GAL
Public Works
Common Area Restroom, Above Ceiling

Water Heater in Poor condition.

This water heater is operational but significantly beyond its expected useful life. - AssetCALC ID: 7668674

Uniformat Code: D2010
Recommendation: **Replace in 2024**

Cost Estimate: \$4,000
