FACILITY CONDITION ASSESSMENT

Griffin Structures - City of Laguna Beach FCA

The Laguna Playhouse
606 Laguna Canyon Road
Laguna Beach, CA 92651

August 14, 2024

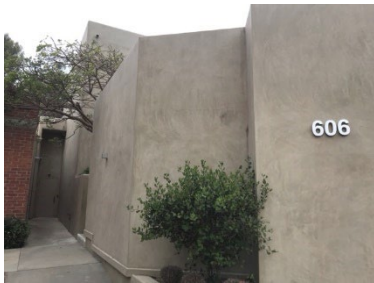
Exterior Walls in Poor condition.

Stucco
The Laguna Playhouse
Building Exterior

Painted plaster over wood frame, plaster is cracking - AssetCALC ID: 7727880

Uniformat Code: B2010
Recommendation: **Prep & Paint in 2025**

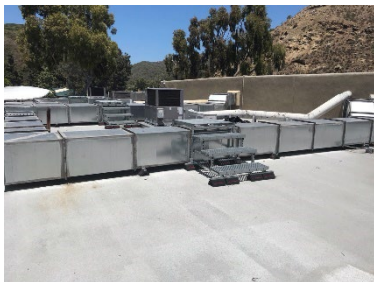
Roofing in Poor condition.

Built-Up
The Laguna Playhouse
Roof

Leaks are reported - AssetCALC ID: 7727893

Uniformat Code: B3010
Recommendation: **Replace in 2025**

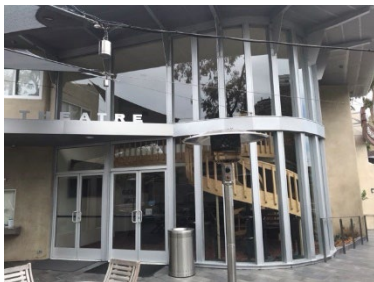
Storefront in Poor condition.

Glazing & Framing
The Laguna Playhouse
Building exterior

Reported in psq that windows leak. - AssetCALC ID: 7908390

Uniformat Code: B2020
Recommendation: **Replace in 2025**

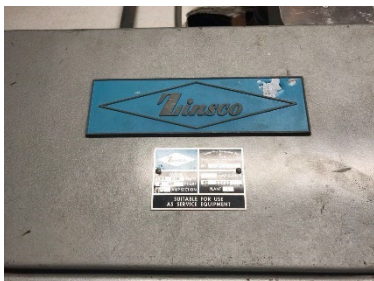
Switchboard in Poor condition.

120/208 V
The Laguna Playhouse
Electrical room

Original to construction of the building, reported electrical issues in psq - AssetCALC ID: 7727840

Uniformat Code: D5020
Recommendation: **Replace in 2025**

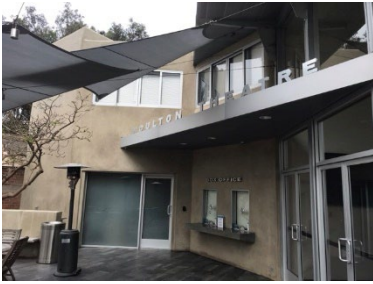
Glazing in Poor condition.

any type, by SF
The Laguna Playhouse
Building Exterior

Single paned, wood frame - AssetCALC ID: 7727824

Uniformat Code: B2020
Recommendation: **Replace in 2026**

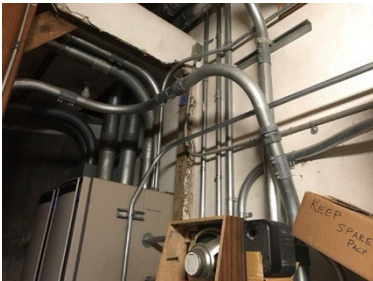
Electrical System in Poor condition.

Wiring & Switches, Average or Low
Density/Complexity
The Laguna Playhouse
Throughout building

Water infiltration destroyed lighting system, but other wiring in original. Study to determine system status is recommended. - AssetCALC ID: 7727767

Uniformat Code: D5030
Recommendation: **Replace in 2024**

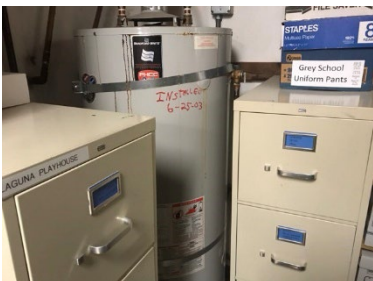
Plumbing System in Poor condition.

Supply & Sanitary, Medium Density (excludes
fixtures)
The Laguna Playhouse
Throughout building

Original to construction. Study should be performed to determine plumbing system needs - AssetCALC ID: 7727769

Uniformat Code: D2010
Recommendation: **Replace in 2024**

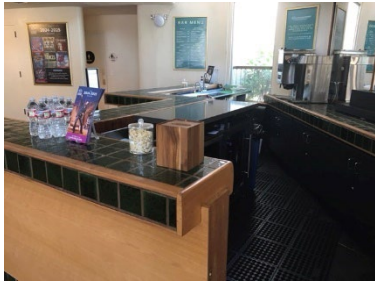
Casework in Poor condition.

Countertop, Ceramic Tile
The Laguna Playhouse
Lobby

Countertop has cracked and dated tiles - AssetCALC ID: 7727847

Uniformat Code: E2010
Recommendation: **Replace in 2026**

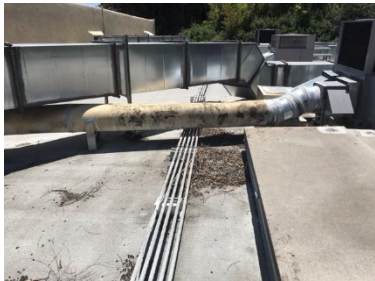
HVAC System in Failed condition.

Ductwork, Medium Density
The Laguna Playhouse
Roof

Original, leaks and other pressure problems - AssetCALC ID: 7727861

Uniformat Code: D3050
Recommendation: **Replace in 2024**

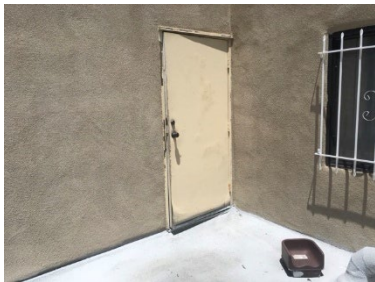
Exterior Door in Poor condition.

Wood, Solid-Core Commercial
The Laguna Playhouse
Building Exterior

Delaminating, door has also been damaged due to break in. - AssetCALC ID: 7727868

Uniformat Code: B2050
Recommendation: **Replace in 2025**

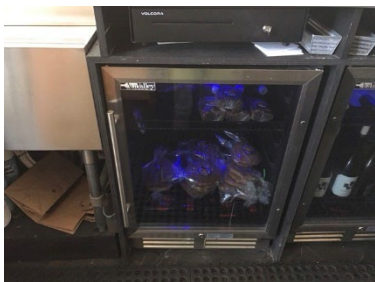
Foodservice Equipment in Poor condition.

Refrigerator, Undercounter 1-Door
The Laguna Playhouse
Lobby

Old with poor seals - AssetCALC ID: 7727766

Uniformat Code: E1030
Recommendation: **Replace in 2026**

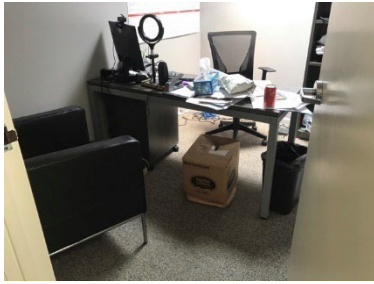
Flooring in Poor condition.

Carpet, Commercial Standard
The Laguna Playhouse
Throughout building

Worn, stained, runs, and tears - AssetCALC ID: 7727890

Uniformat Code: C2030
Recommendation: **Replace in 2026**

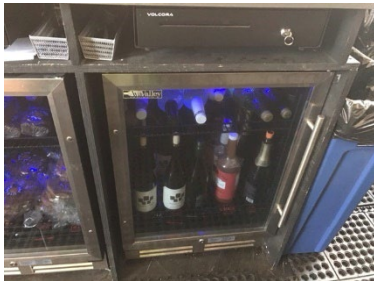
Foodservice Equipment in Poor condition.

Refrigerator, Undercounter 1-Door
The Laguna Playhouse
Lobby

Old with poor seals - AssetCALC ID: 7727750

Uniformat Code: E1030
Recommendation: **Replace in 2026**

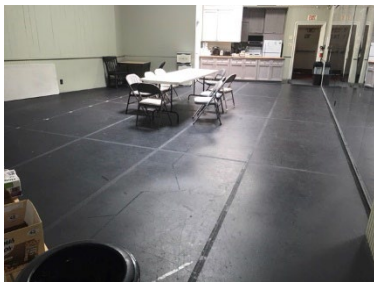
Flooring in Poor condition.

Rubber Tile
The Laguna Playhouse
Green Room

General wear and tear over a long life - AssetCALC ID: 7727866

Uniformat Code: C2030
Recommendation: **Replace in 2026**

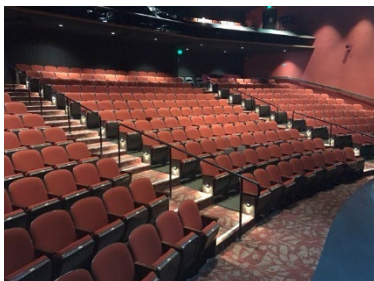
Fixed Seating in Poor condition.

Auditorium/Theater, Metal Cushioned Standard
The Laguna Playhouse
Theater

Seats are antiqued and hard to find parts fr repair - AssetCALC ID: 7727895

Uniformat Code: E2010
Recommendation: **Replace in 2026**

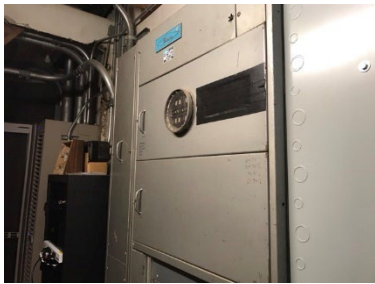
Electrical distribution is original. Wiring insulation is naturally failing from age. Electrical system study recommended to determine overall scope of work required for upgrade. - AssetCALC ID: 7836078

Uniformat Code: P2030
Recommendation: **Design in 2024**

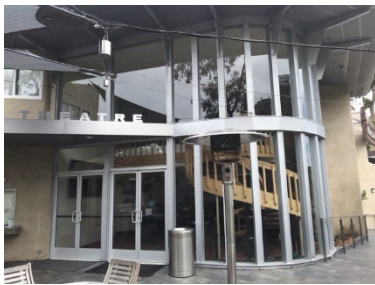
Both roof and facade have been surface repaired, with underlying issues covered up. Roof deck needs to be replaced and exterior facade needs to be replaced. Study recommended to determine total scope of project. - AssetCALC ID: 7836076

Uniformat Code: P2030
Recommendation: **Evaluate/Report in 2024**

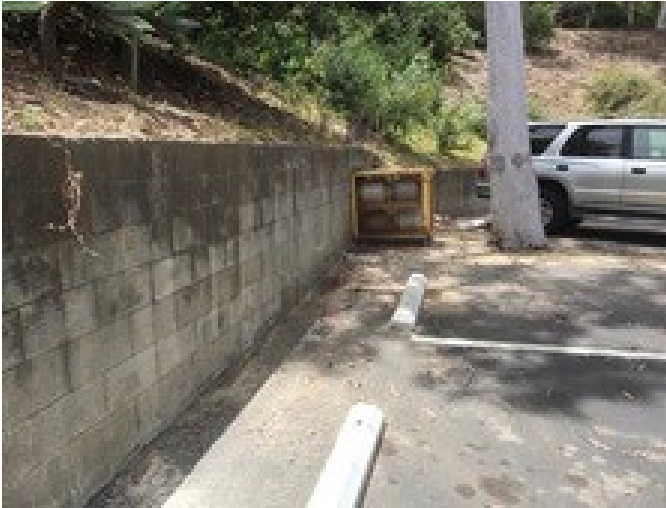
5 - RETAINING WALL

Site Additional Studies	One study is recommended for the site: The retaining wall on the North, west, and south border is in poor condition. Recent rain led to a portion of the retaining wall to fail during a large rain event during the previous winter. The rest of the retaining wall around the parking lot and as part of the building structure should be investigated to determine if the retaining wall is still holding in other locations. A professional engineer, architect, or consultant must be retained to analyze the existing condition, provide recommendations and, if necessary, estimate the scope and cost of any required repairs. The cost of this study is included in the cost tables. Due to the ambiguity of the required repair scope at the time of this assessment, the cost for any possible subsequent repairs is not included.
Site Areas Observed	The exterior areas within the property boundaries were observed to gain a clear understanding of the site's overall condition.
