FACILITY CONDITION ASSESSMENT

Griffin Structures - City of Laguna Beach FCA _Inventory_PMP

October 14, 2024

Corporation Yard
1900 Laguna Canyon Road
Laguna Beach, CA 92651

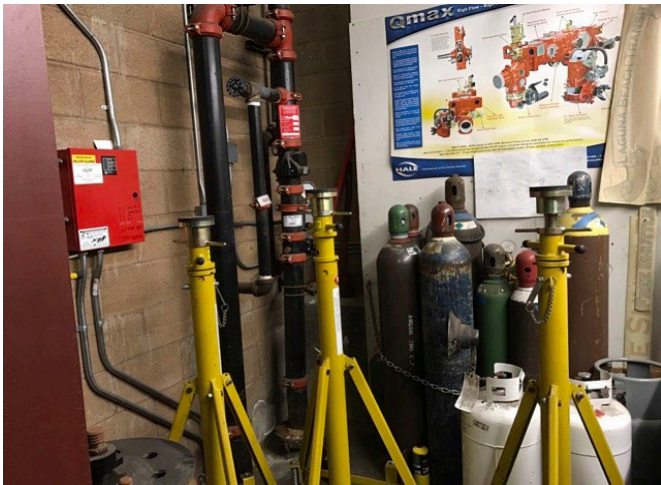
21 – FIRE RISER

When it rains water comes into building apparently from below grade under slab, or through inside CMU walls to grade, then seeping out of lowest blocks where the efflorescence is observed. - AssetCALC ID: 7649577

There is water infiltration in the maintenance shop, near the fire riser, of unknown origin. A professional consultant must be retained to analyze the existing condition, provide recommendations and, if necessary, estimate the scope and cost of any required repairs. The cost of this study is included in the cost tables. Due to the ambiguity of the required repair scope at the time of this assessment, the cost for any possible subsequent repairs is not included.

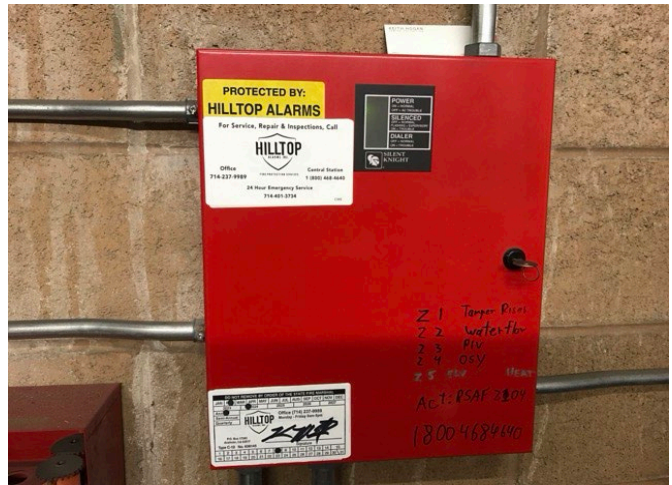
22 – ALARM PANEL

Fire Alarm Panel in Poor condition.

Uniformat Code: D7050
Recommendation: **Replace in 2024**
