FACILITY CONDITION ASSESSMENT

Griffin Structures - City of Laguna Beach FCA

Laguna Beach Community & Susi Q Center
380 Third Street
Laguna Beach, CA 92651

August 26, 2024

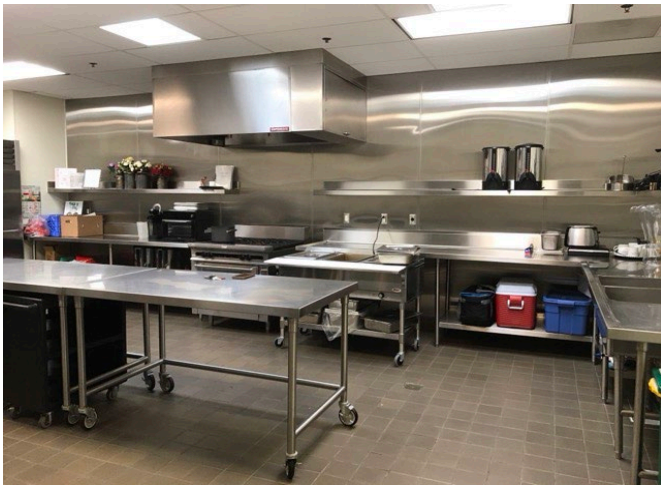
21 – KITCHEN

The foodservice equipment is in fair condition, with the kitchen exhaust hood in poor condition.

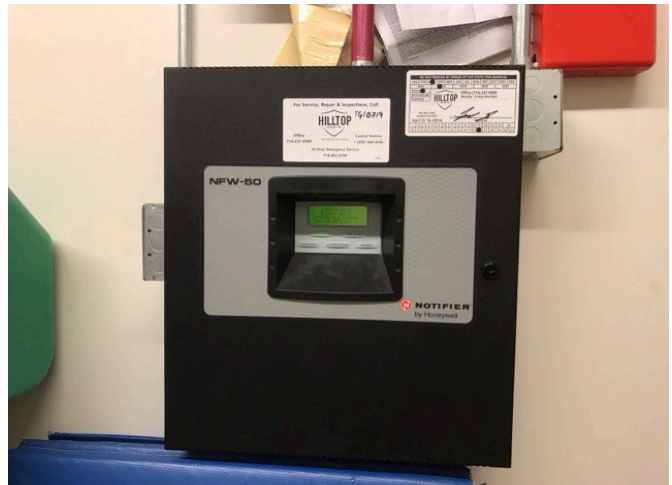
28 – FIRE ALARM

The fire alarm panel is beyond its expected useful life and in poor condition. The fire alarm and security systems are in fair condition.

The fire alarm panel has reached the end of its expected useful life and should be replaced soon. -
AssetCALC ID: 7690441

Uniformat Code: D7050
Recommendation: **Replace in 2024**
