**BUREAU
VERITAS**

FACILITY CONDITION ASSESSMENT

Griffin Structures - City of Laguna Beach FCA

Public Works
479 Ocean Avenue
Laguna Beach, CA 92651

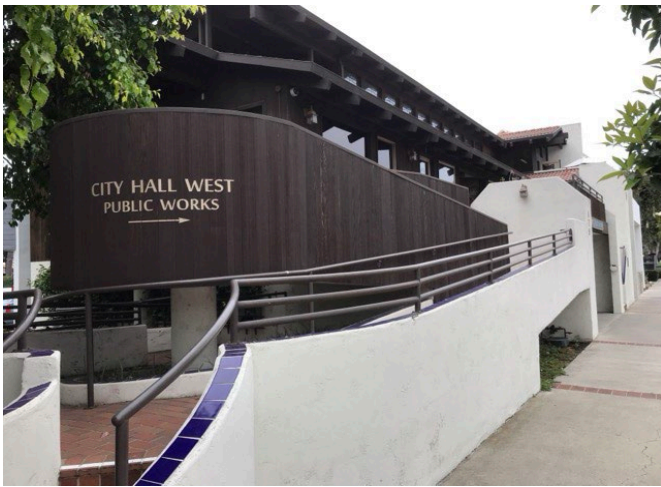
3 – EXTERIOR WALLS

Exterior Walls in Poor condition.

Stucco finishes at exterior ramp and planters are damaged. - AssetCALC ID: 7668672

Uniformat Code: B2010
Recommendation: **Repair in 2024**
