FACILITY CONDITION ASSESSMENT

Griffin Structures - City of Laguna Beach FCA

The Laguna Playhouse
606 Laguna Canyon Road
Laguna Beach, CA 92651

August 14, 2024

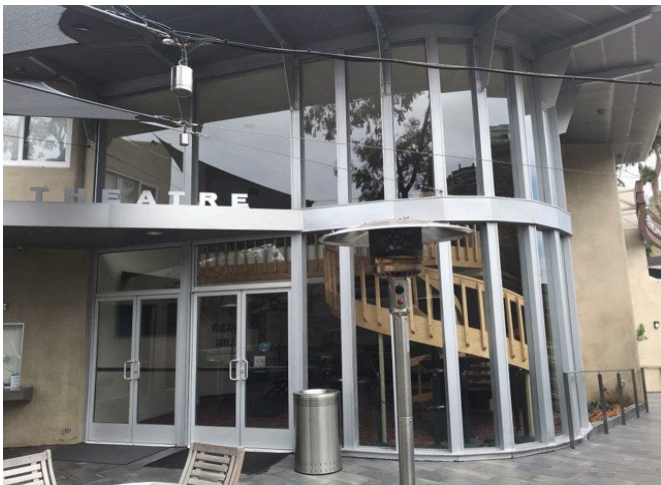
5 – STRUCTURAL GLAZING

Glazing in Poor condition.

Uniformat Code: B2020
Recommendation: **Replace in 2026**

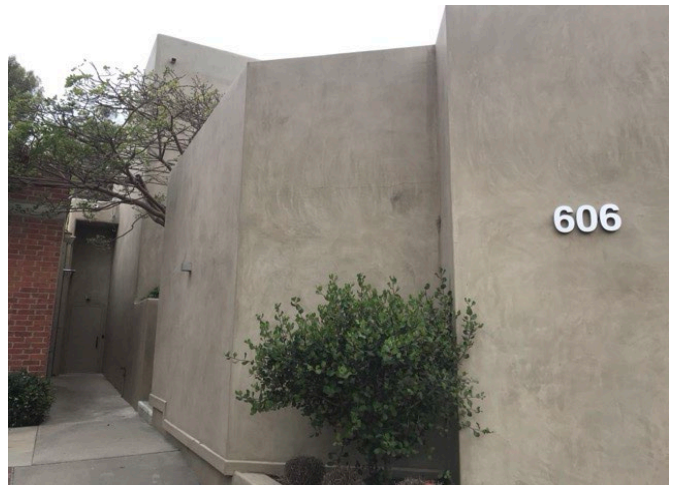
6 – EXTERIOR WALLS

The building has a wood framed flat roof with a built-up roof finish. The exterior walls are wood framed and have been plastered and painted within the last year. The plaster is cracking due to structural movement. The interiors are dated and carpet throughout is worn due to high traffic and age. The exterior windows are wood framed and single paned. An engineering study for the façade and roof decks is recommended to determine the overall costs of replacing the roof deck and facade structures.

Exterior Walls in Poor condition.

Painted plaster over wood frame, plaster is cracking - AssetCALC ID: 7727880

Uniformat Code: B2010
Recommendation: **Prep & Paint in 2025**

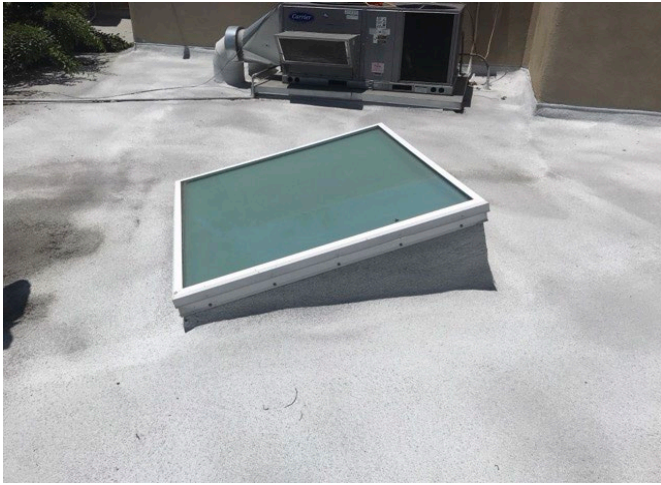
7 – ROOFING AND ROOF SKYLIGHT

Roofing in Poor condition.

Leaks are reported - AssetCALC ID: 7727893

Uniformat Code: B3010
Recommendation: **Replace in 2025**

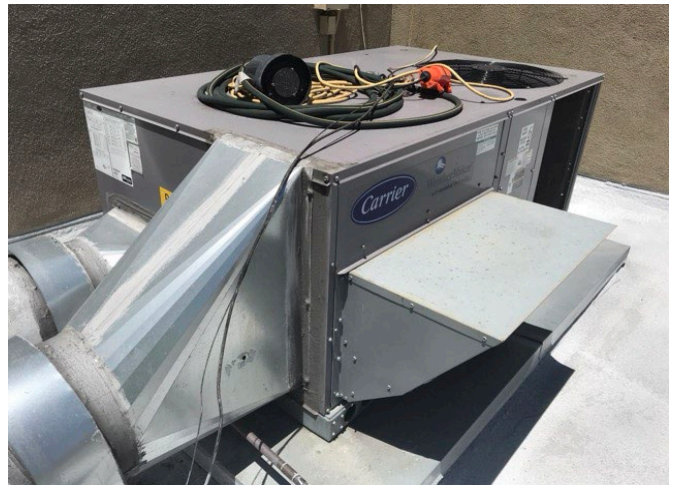
16 – PACKAGED UNIT

HVAC System in Failed condition.

Original, leaks and other pressure problems - AssetCALC ID: 7727861

Uniformat Code: D3050
Recommendation: **Replace in 2024**

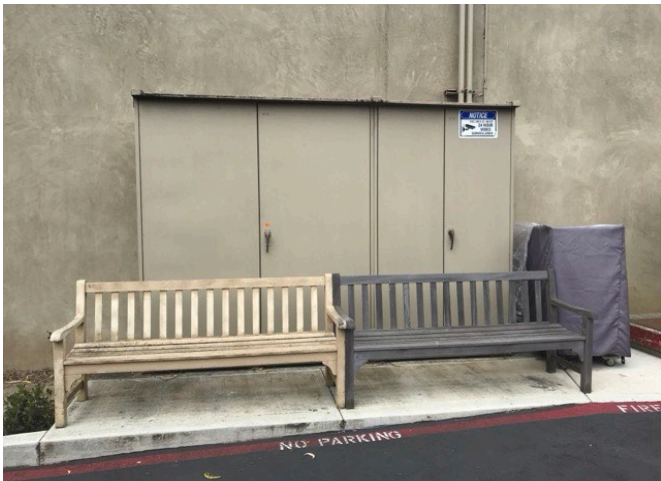
17 – MAIN SWITCHBOARD

Switchboard in Poor condition.

Uniformat Code: D5020
Recommendation: **Replace in 2025**
